# Wooden Boat

## Raising CHRISTIANIA

A sunken maritime treasure is retrieved and restored

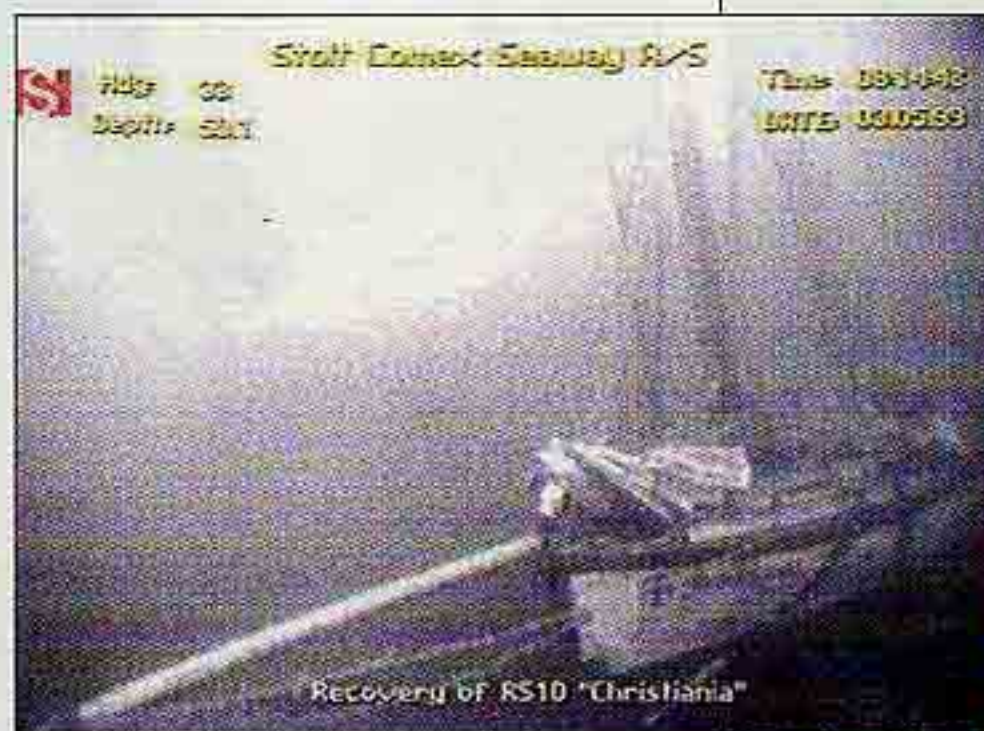
CHRISTIANIA rises from the sea floor. She was lifted most of the way in a bow-up attitude, and was leveled before she reached the surface.

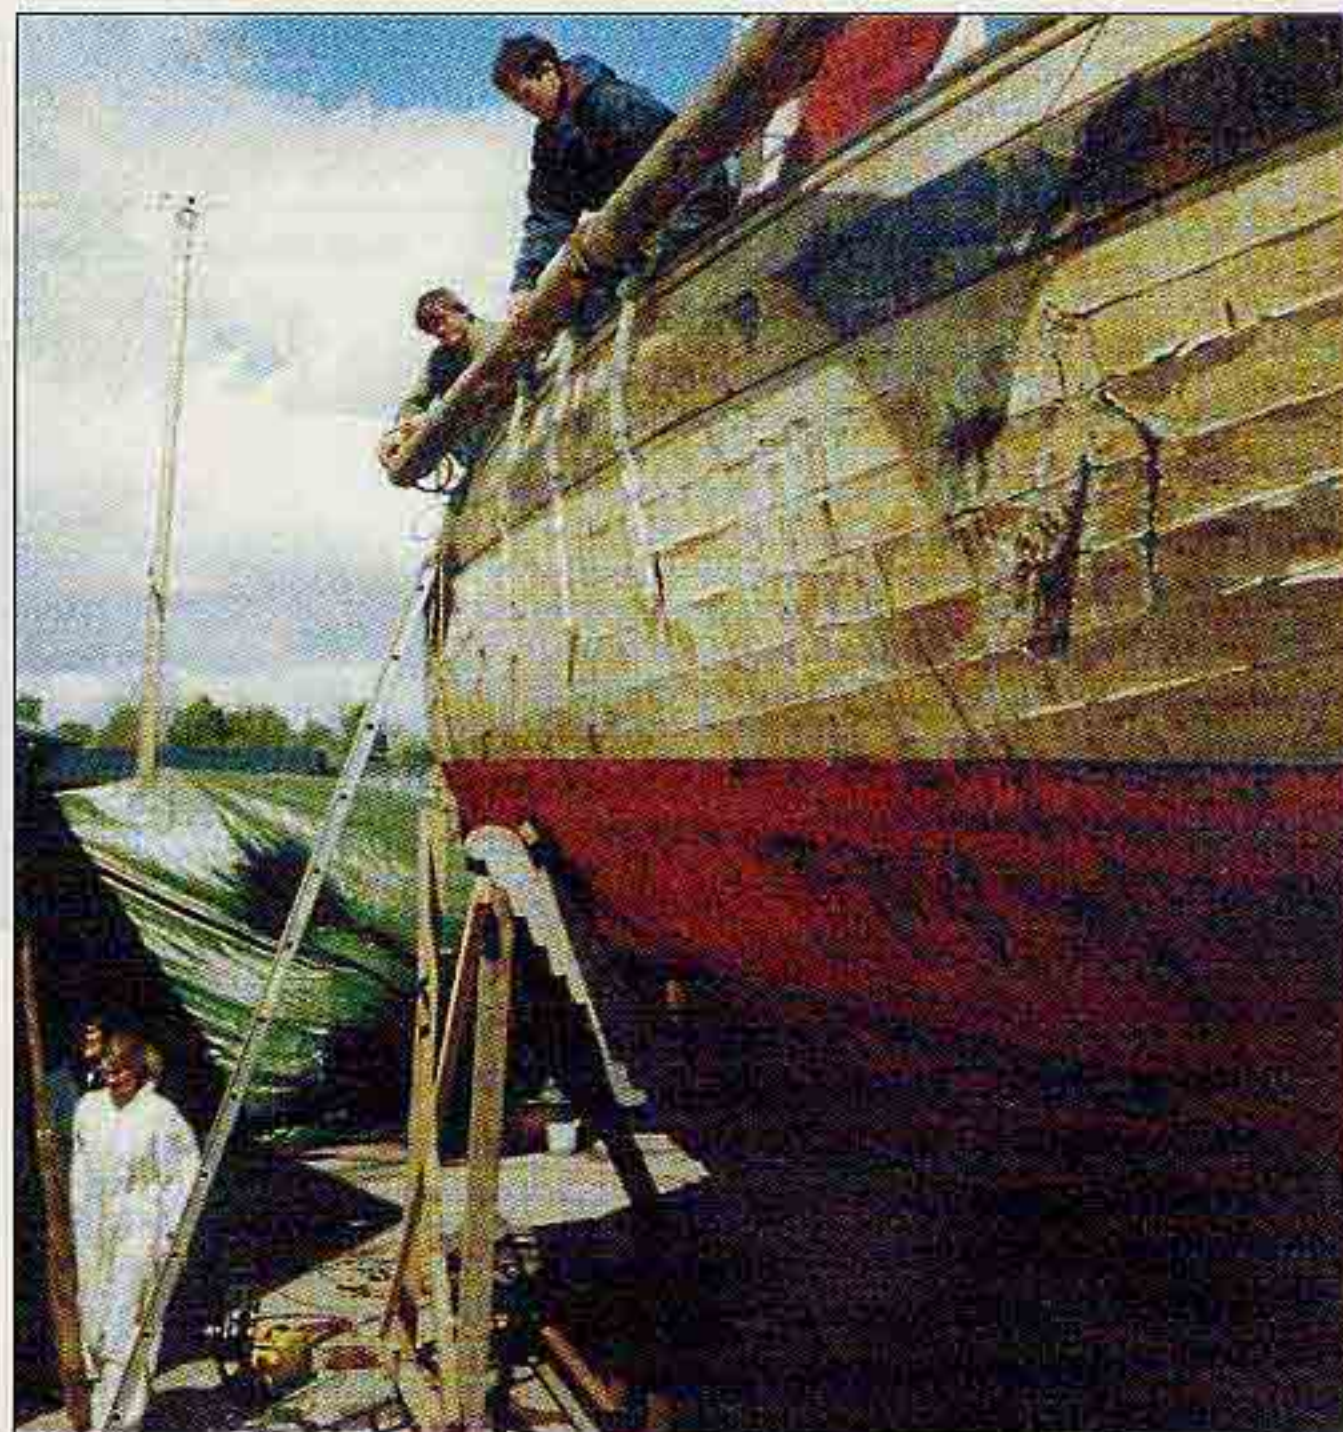
**Above**—Throughout the entire recovery and rebuilding, many Petersen family friends contributed time and advice. Here, a volunteer crew cleans and dismantles CHRISTIANIA at the yard in Telemark.

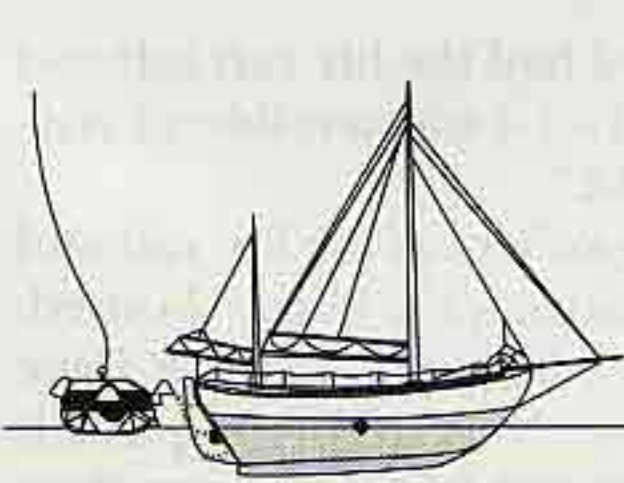
1. Cut rudder hinges with grinder, remove rudder

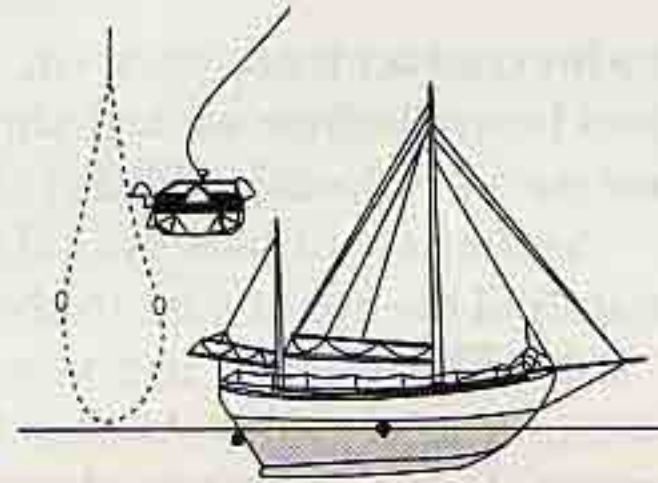
2. ROV guides lifting slings into position

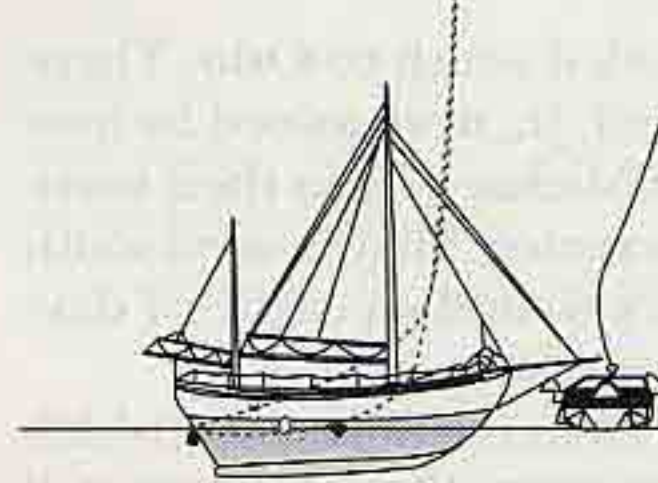
3. Lower lifting cable, which is led through surface ship's "moon pool"

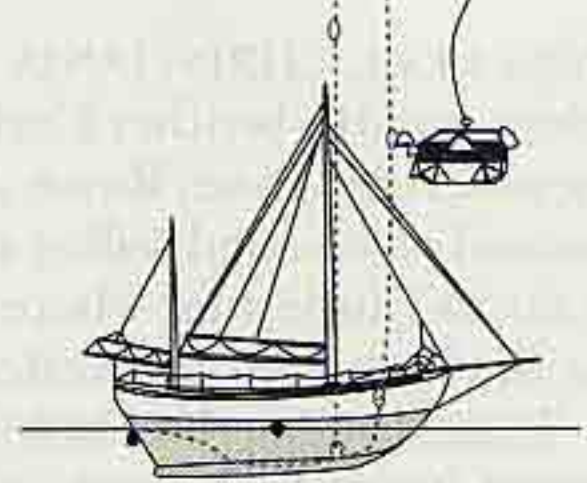
4. Fasten fore sling to master link 1 using ROV

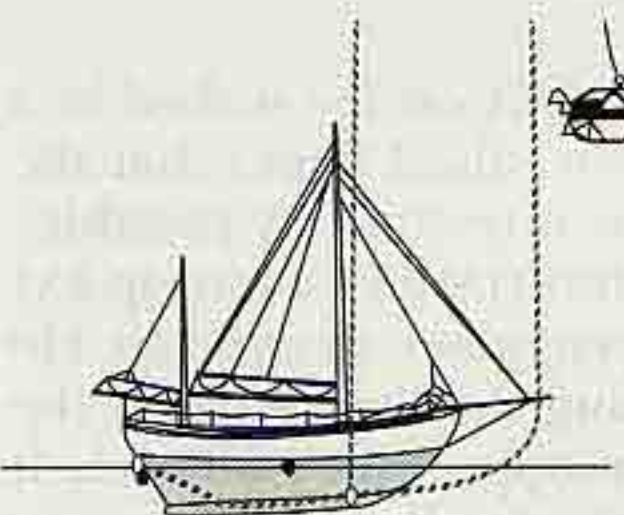
5. ROV swims around and fastens fore sling in master link 2

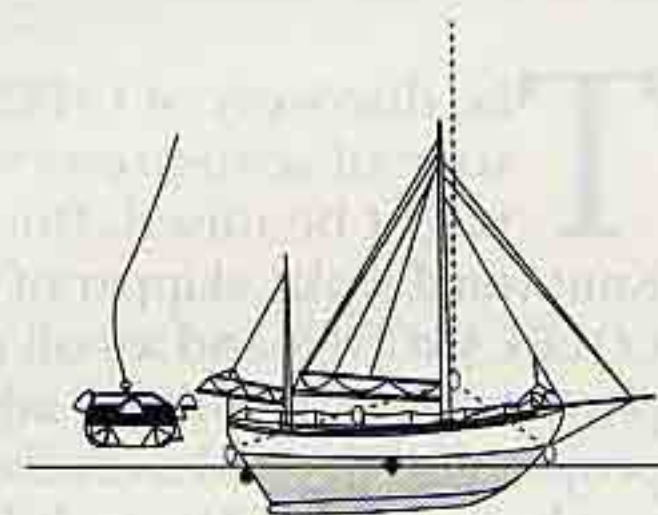
6. Apply tension to cable while using jet to dredge around hull

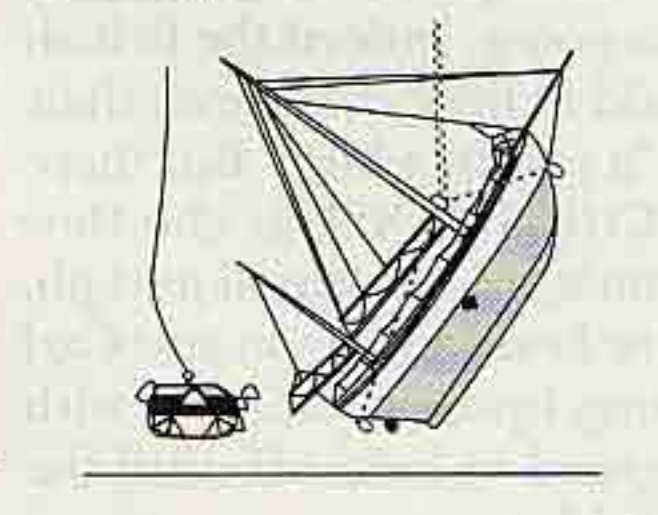
7. Lift CHRISTIANIA

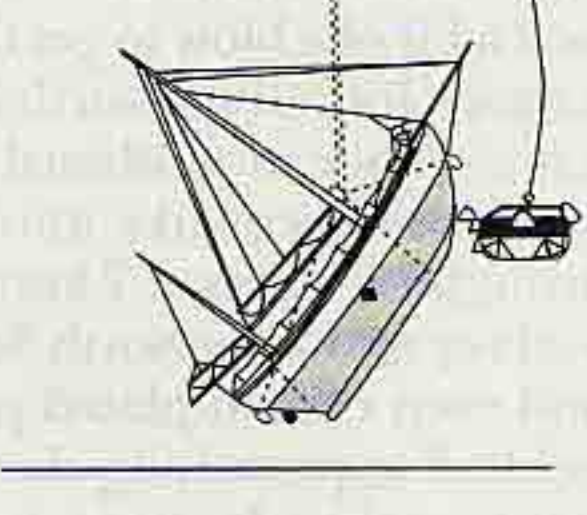
8. ROV fastens three security slings

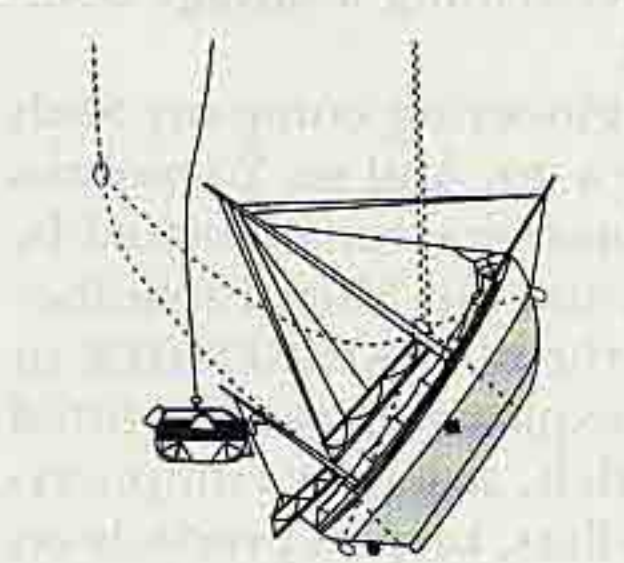
9. Fasten lift slings to crane cable, which leads over KINGFISHER's side

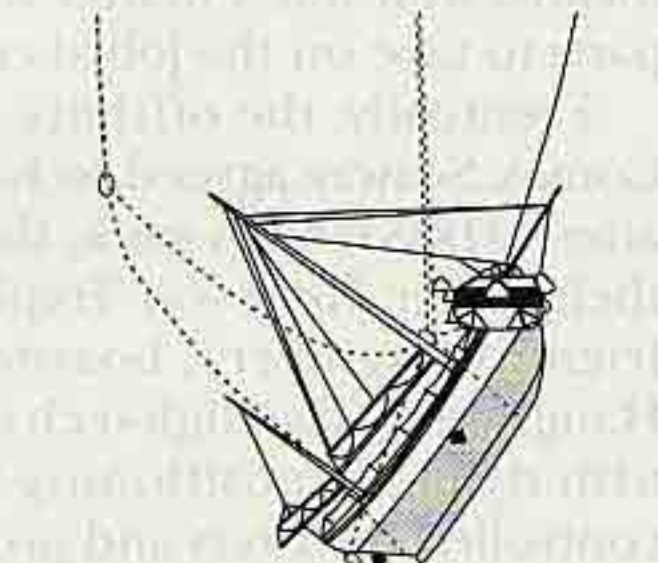
10. Fasten forward lift sling to crane cable

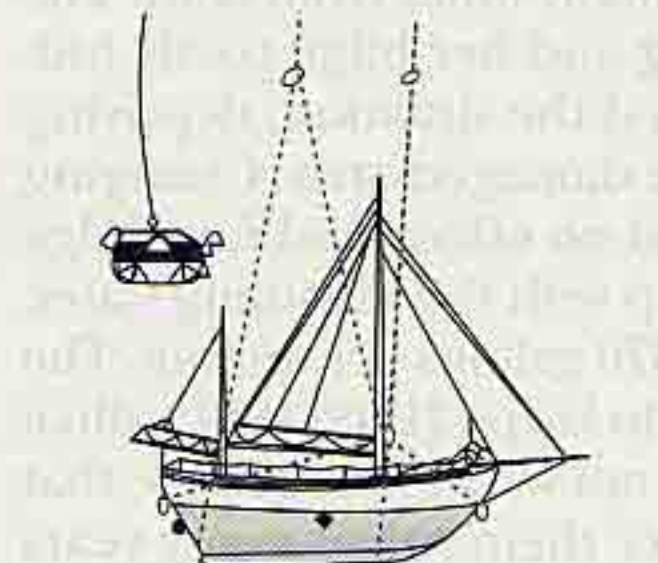
11. Lower moon pool wire until crane takes entire load

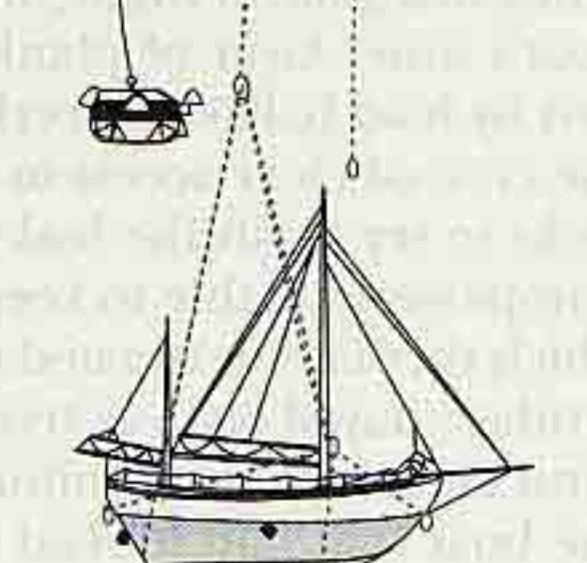
12. Disconnect and withdraw moon pool cable, and lift until CHRISTIANIA's main deck breaks surface alongside KINGFISHER

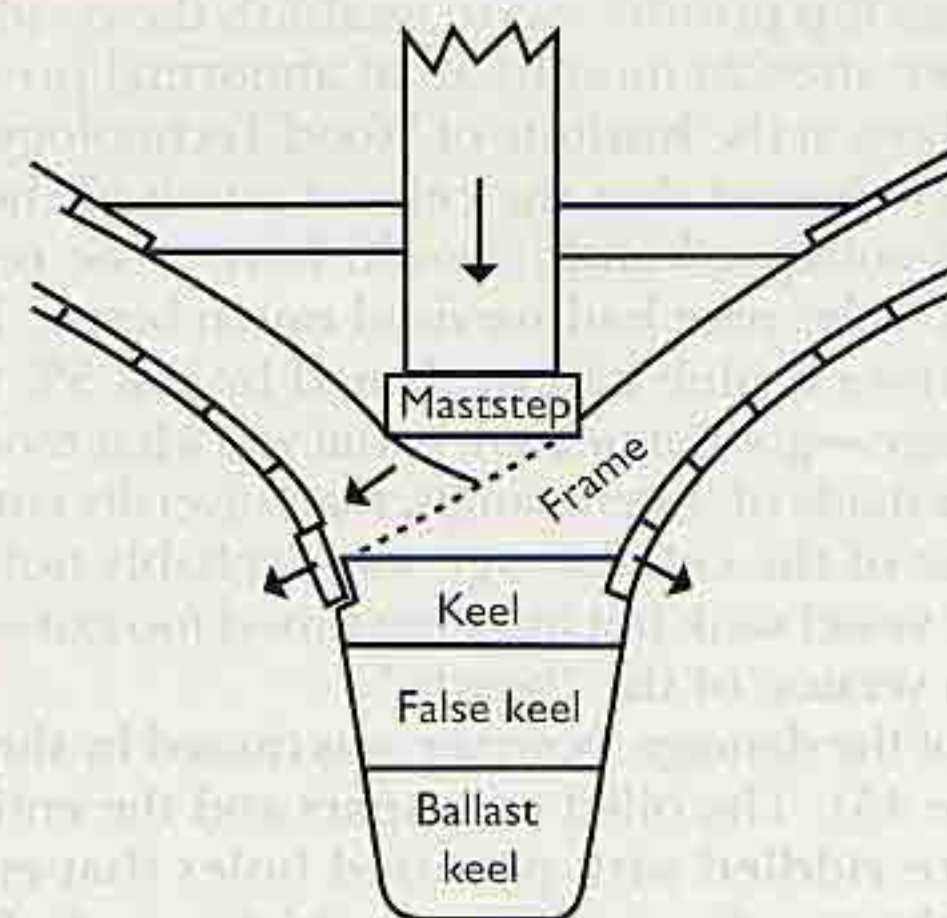
A section of the maststep area showing the forces and construction flaw that caused CHRISTIANIA’s sinking. The maststep spread the ends of the two-piece floor timber, which wedged the garboards from the rabbet.

answer was not long in coming. A gap of about  $\frac{1}{4}$ "– $\frac{1}{2}$ " along 10' on either side of the maststep was the clue. (The gap was probably larger when CHRISTIANIA went down and may have narrowed due to swelling and the impact of hitting the seabed.) Closer inspection revealed that the doubled floor timber directly under the mast was not built to Colin Archer's specifications. Instead of both timbers being made of single lengths of wood, as detailed in Archer's plans, the almost had a butt joint in the middle. With age, the nails holding the timbers together had grown tired and allowed some movement between them. As the mast pressed down on the maststep, the step pushed down like a wedge, pushing the two halves of the jointed floor timber apart and opening the garboard seam in the process. It was a small mistake by one builder, probably due to a shortage of good oak, but 102 years later it was enough to sink the boat.

in Stathelle, who clocked up a total of nearly 9,000 hours. Besides replacing the worm-eaten and pressure-damaged timber, the yard also added substantial reinforcement to the area around the maststep. The keelson was reinforced by a steel plate to spread the pressure from the mainmast, and additional laminated frames were fitted in the area. At the same time, the damaged wooden keel was replaced, along with 40% of the planking—overall, about 30% of the hull timber was renewed. The Petersens took this opportunity to make a few long-wished-for alterations below deck, including double berths fore and aft and a better-working navigation area. The mizzenmast was returned to its original position a foot farther aft, allowing for a larger mainsail, and the rigging beefed up to rescue ship MkIII standards. Other original features, such as the separate storage area in the bow, were reinstated. A new engine was fitted, but many of the old fittings survived, including the Simpson & Lawrence heads, which merely needed a new set of flanges; most of the well-greased shackles could still be opened by hand pressure alone.
